# Comparative Analysis

Building Alteration and Renovation versus Demolition  
Saint Paul's Complex, Garden City, NY 11530

March 30, 2023

**Existing MEP/FP Condition Evaluation  
&  
Adaptive Reuse Analysis**

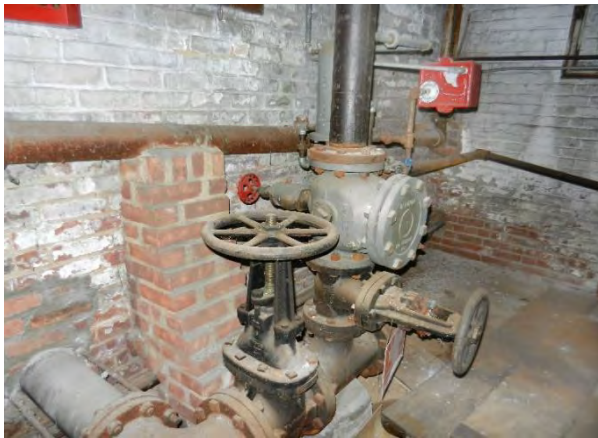
The current fire protection system supply is fed from the existing water service.

- A. Any Smoke Detectors installed throughout the building are inoperative, do not meet current codes and cannot be reused.
- B. Fire hose reels are installed at locations near fire exits. These do not meet current codes and the piping is not suitable for reuse due to age and corrosion.
- C. The current building is not protected with a comprehensive sprinkler fire system throughout. Sprinklers are only in the basement and hallways.
- D. The current gas service that enters the building is 2" low pressure gas line. That service has been abandoned.

- E. The plumbing piping system including waste, vent, water piping is original to the building. Systems show signs of failure, waste, and vent piping (cast iron) is cracking. There is some evidence of more updated piping in some areas where replacement was done due to failure. These systems cannot be reused.
- F. The plumbing fixtures in the building are original. Existing plumbing fixtures in the bathrooms include floor mounted tank type water closets. Urinals are wall hung type with flush valve. These fixtures do not conform to current water conservation code requirements.

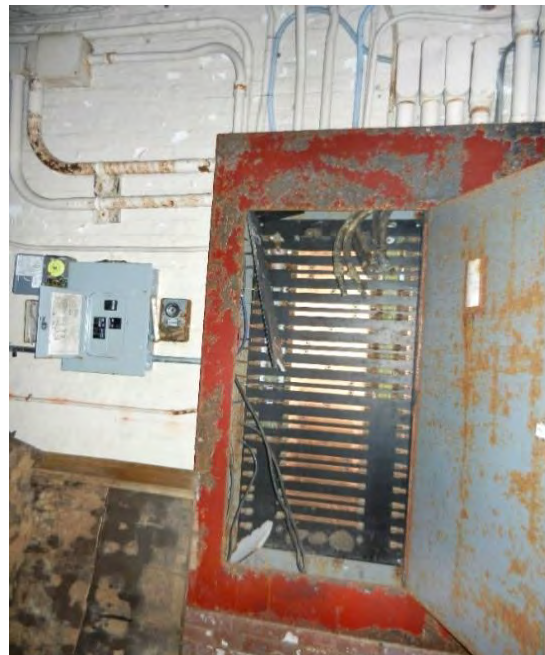
- A. The existing electrical service to the building is provided by underground feeders that run to service disconnects the electrical distribution is outdated. Most panel locations are not code compliant with regards to mounting heights.
- B. The entire electrical system is scavenged and needs to be replaced as it is non-compliant with current electrical loads and code. See photos above.

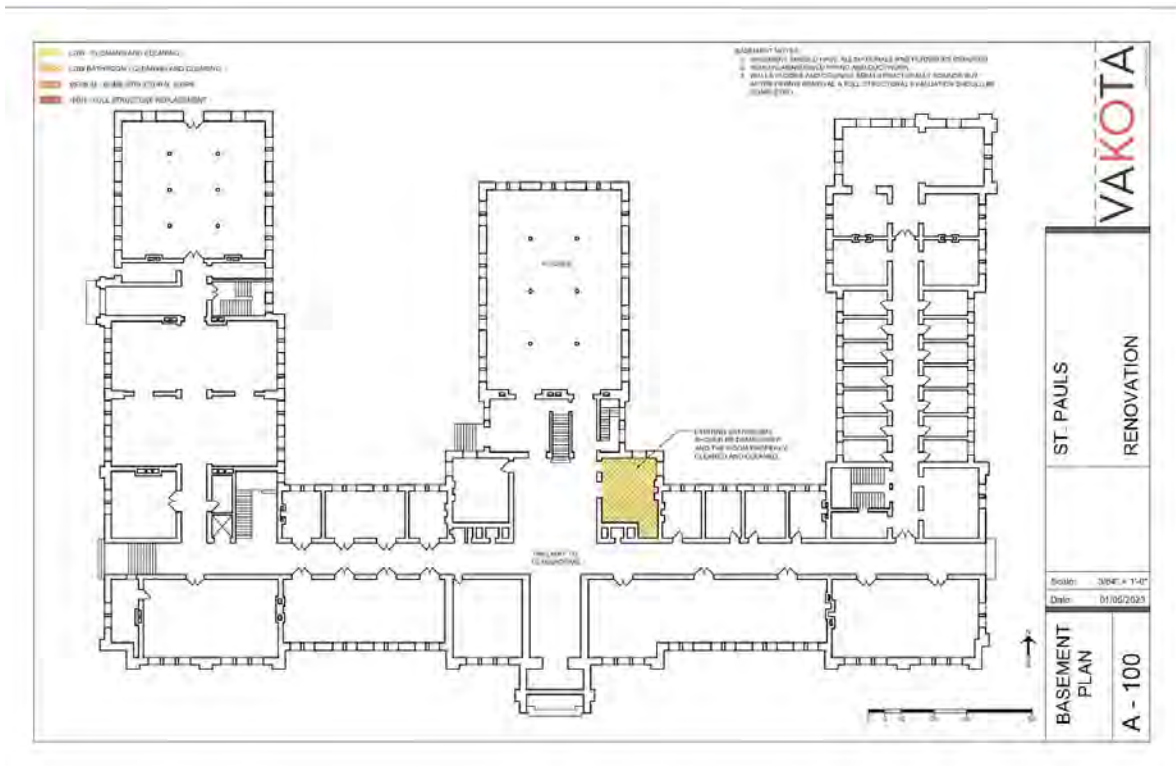
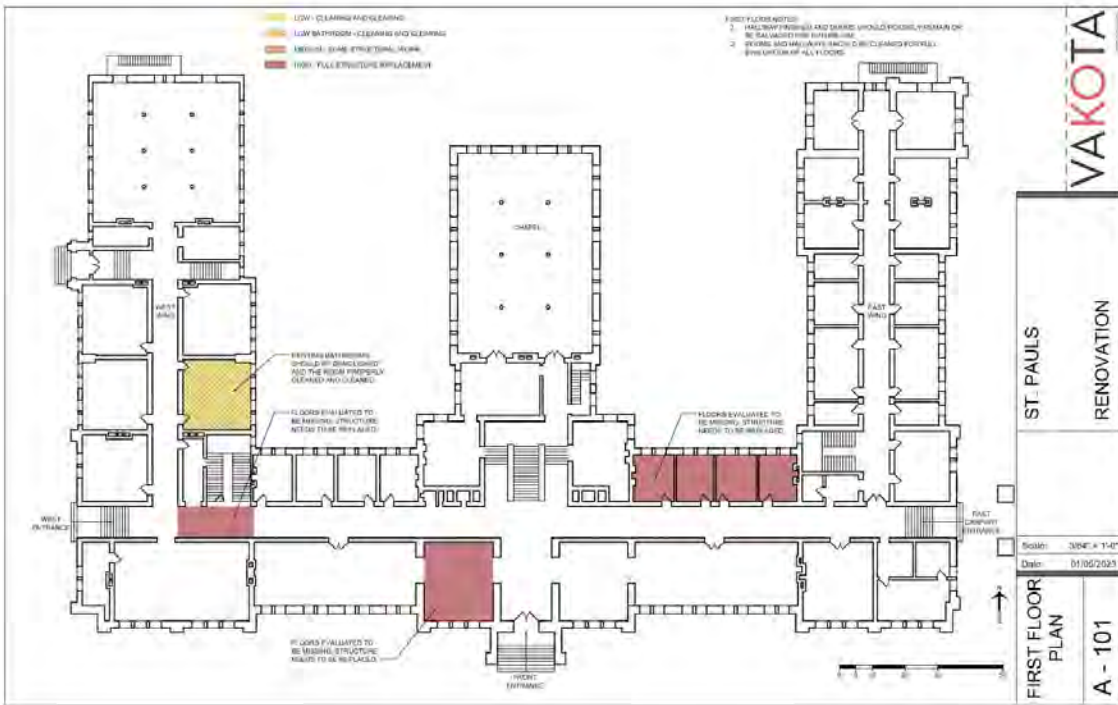
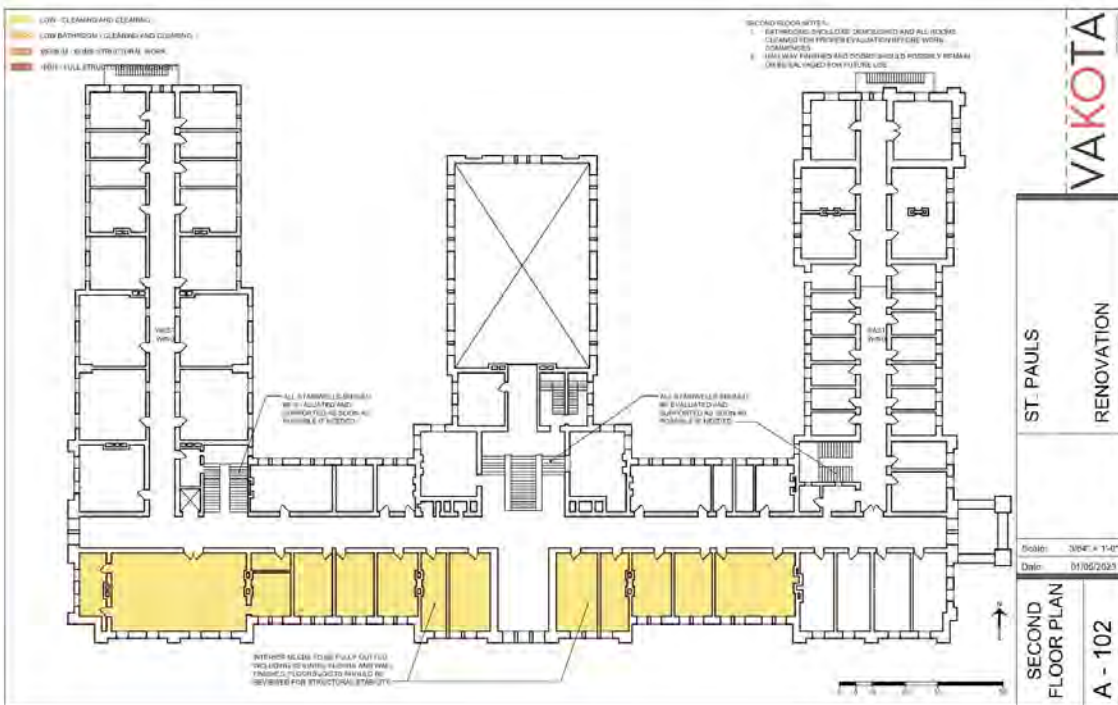
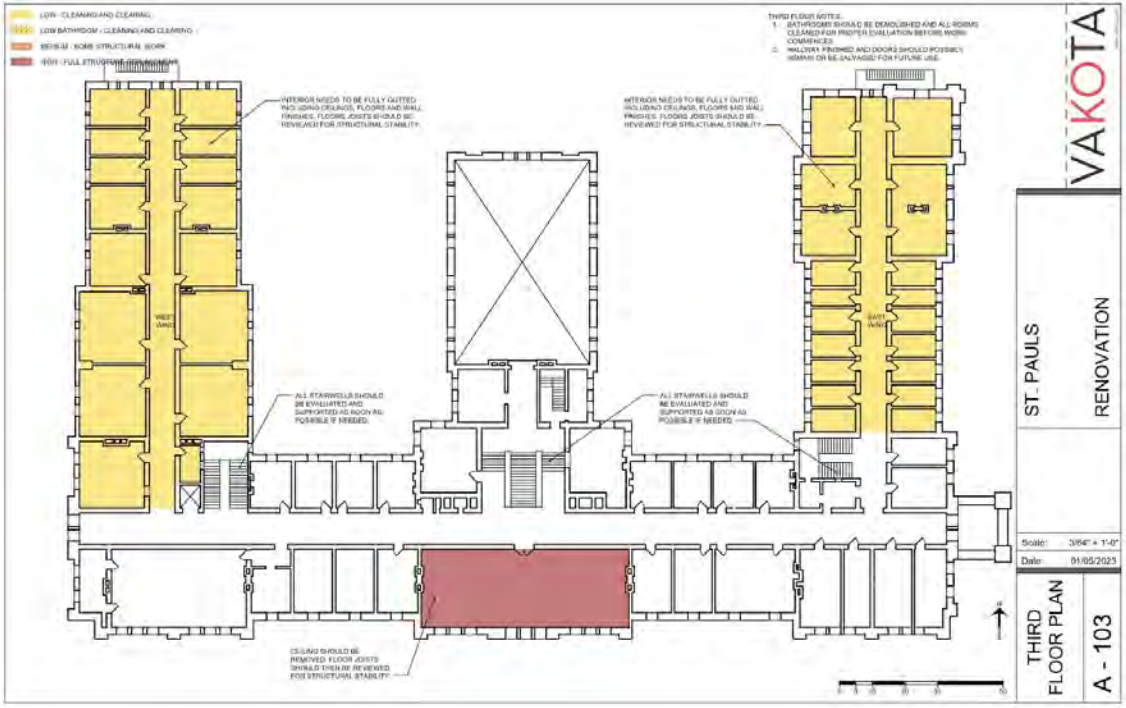
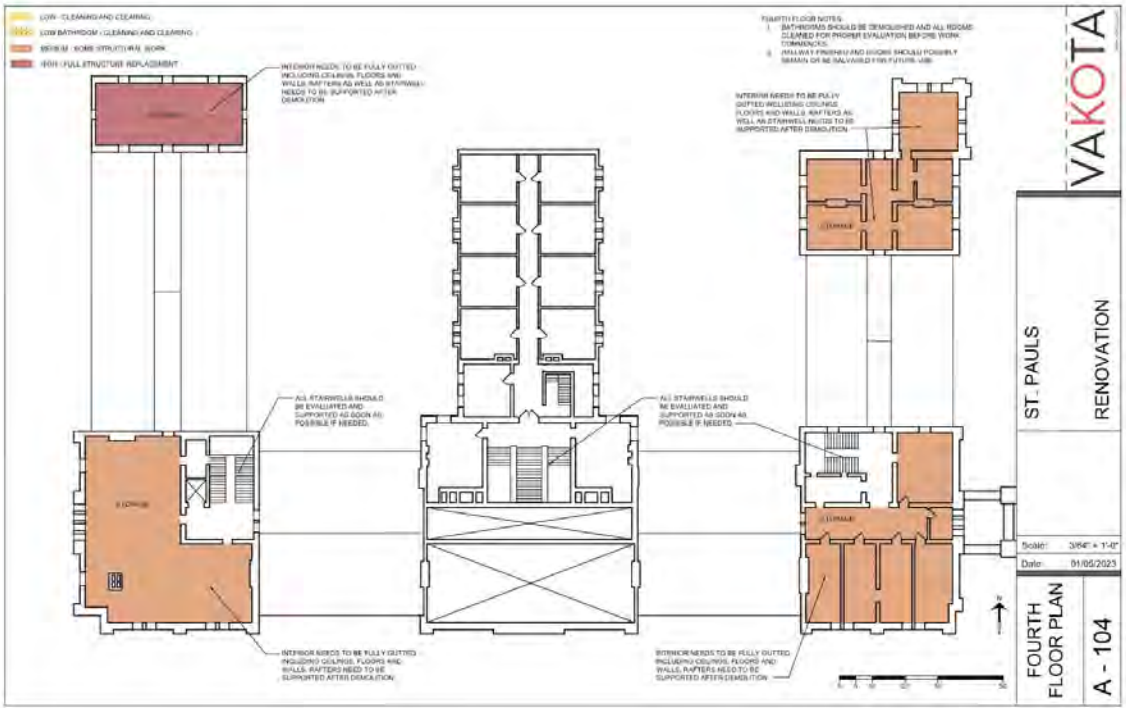
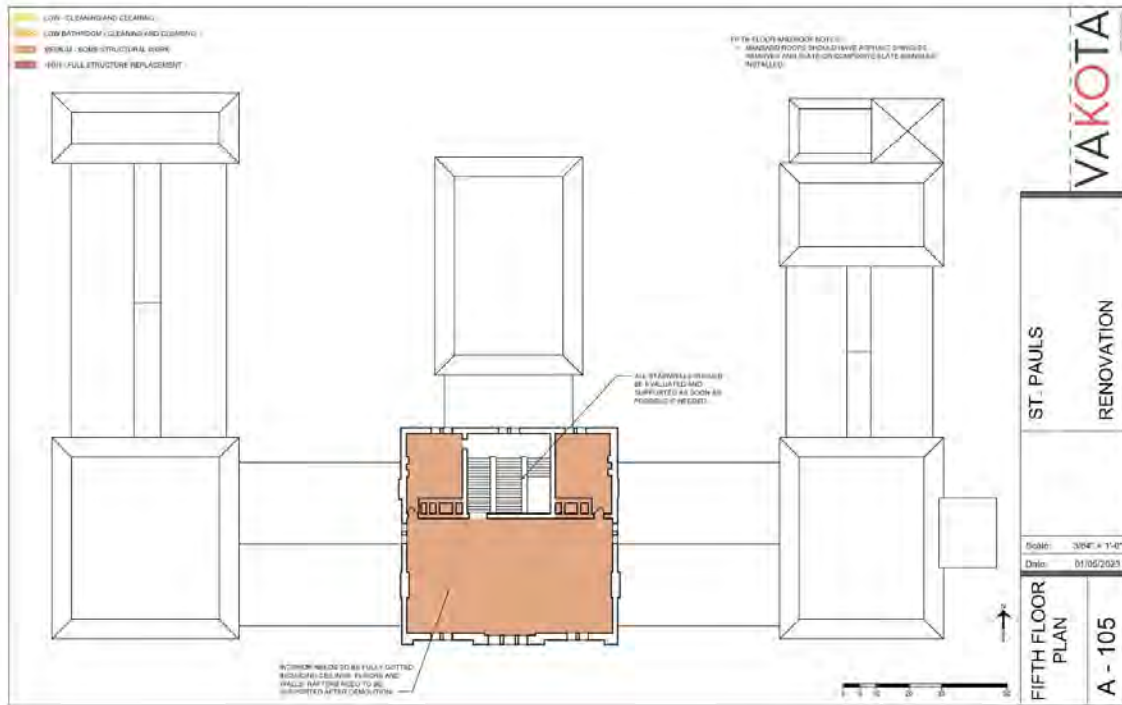
The following diagrams show the existing conditions as observed on December 09, 2022. No extensive probes or reviews were performed. Areas with noticeable deterioration, environmental hazards, and structural compromise have been highlighted. An extensive structural review was not performed although random samples of walls, ceilings, and floors were taken for asbestos and moisture testing.

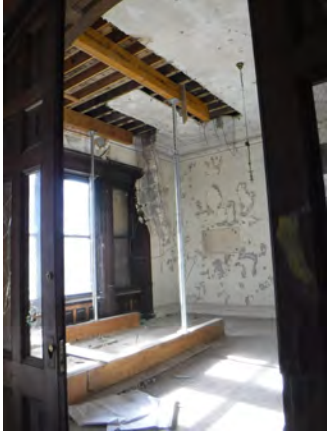
Shoring example on second floor

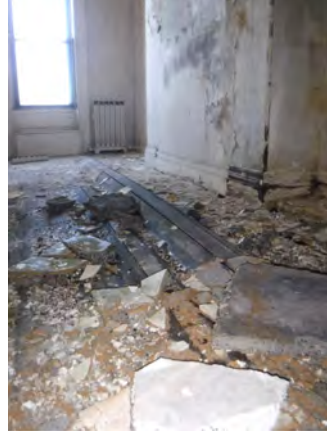
There were several locations throughout the building where the floors have either collapsed completely or are severely deflected downward as a result of wood rot. It appears that the wet masonry has caused wood rot in the joists to such an extent that they have sheared off where they were pocketed into the brick. For this to have happened under just the weight of the dead load is a verification that the wood rot is extensive in some areas. Typical floors in this building should be able to support a dead load of approximately 20 pounds per square foot (PSF) of floor area as well as a live load likely on the order of 60 PSF for a total load capacity of 80 PSF. The fact that the floors sheared off under just that dead load (20 PSF/80 PSF) or just 25% of its likely rated capacity means that the rot is extensive.

Floor damage

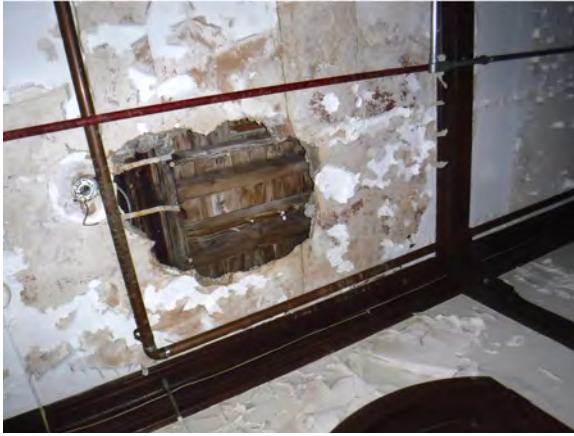
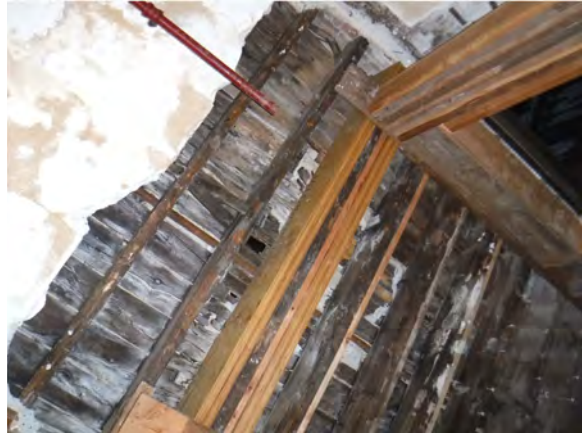
In some areas the ceiling, consisting of 1-1/2" thick fireproofing has delaminated from the ceiling. This is a safety concern as it leaves the wood joists exposed to fire but also due to the type of failure we are concerned of more ceiling delamination. The fire-proofing is attached to the wood joists with nails. In the areas where the plaster has fallen, we noticed the nails had rusted and broken away from the structure. It would be our assumption that more areas have this deterioration and further delamination is imminent.

Typical ceiling

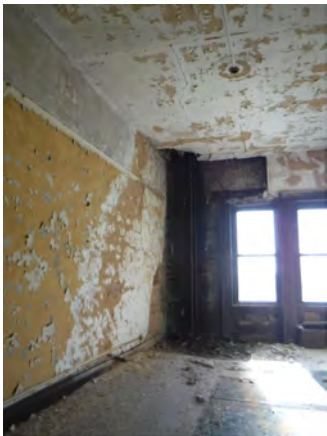
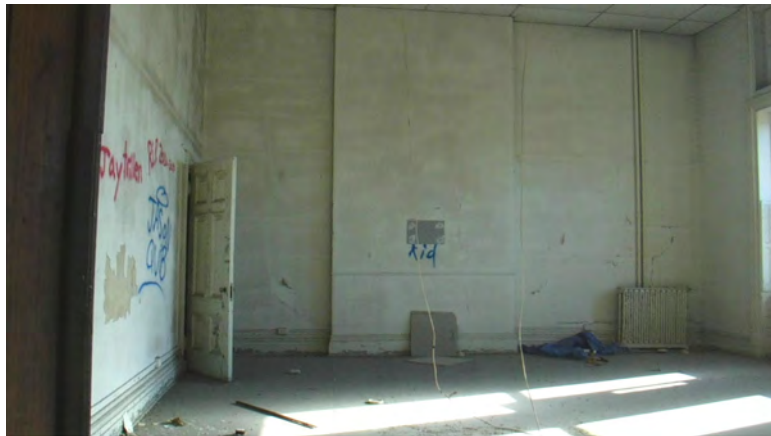
Typical room conditions

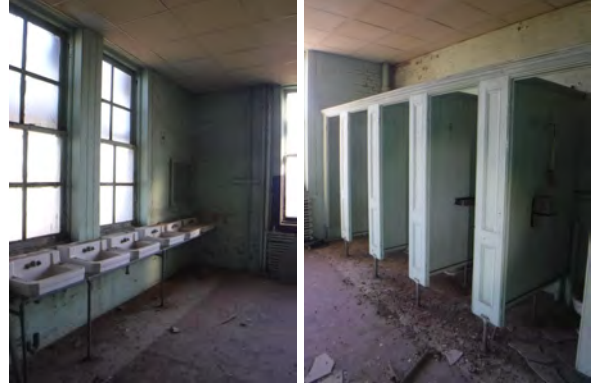
Typical restrooms

- Bathrooms should be gutted and all fixtures removed.
- Rooms with collapsed floors and structural damage should be shored up and areas closed off. Existing floors should be cleaned out.
