# The Structural Integrity of St. Paul's Remains Sound

This report highlights the key findings resulting from the Design & Engineering Subcommittee's second site inspection of St. Paul's on March 18, 2022. A previous structural investigation was initiated by the prestigious engineering firm of Thornton Tomasetti and resulted in declaring the St. Paul's building to be in good condition for re-development.

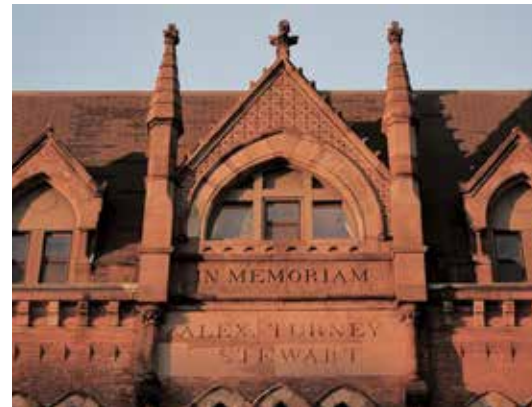
As the report details, the "primary structural systems are intact and stable, and can be used for a future use." This is an important declaration, for it eliminates the need to demolish St. Paul's on the grounds of not being of structurally sound construction and therefore a current danger to the public. In fact, the exterior walls remain very stable, and given the tight mortar joints employed, show

virtually no signs of water infiltration. There are limited indications of disrepair along the various brownstone and sandstone architectural decorative details, but these can be rectified and pose no structural threat.

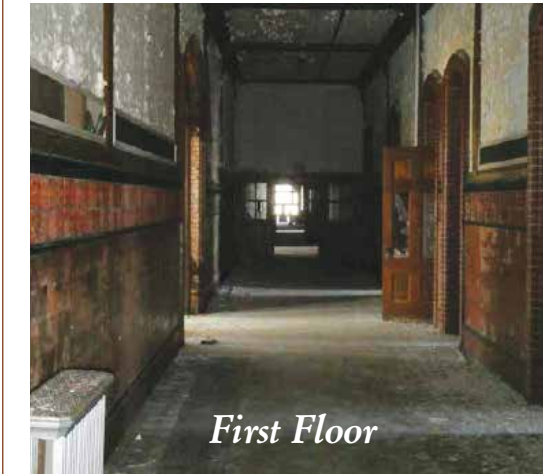
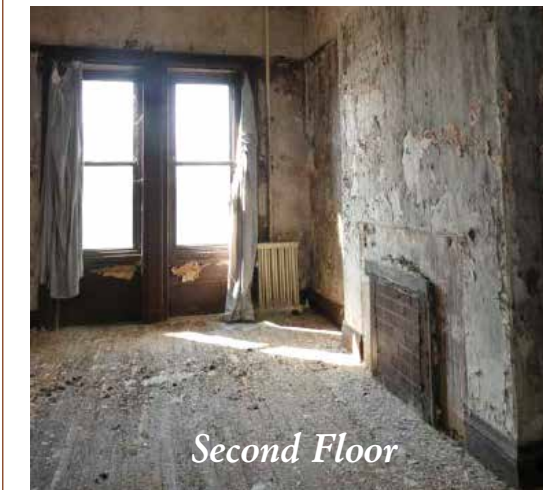
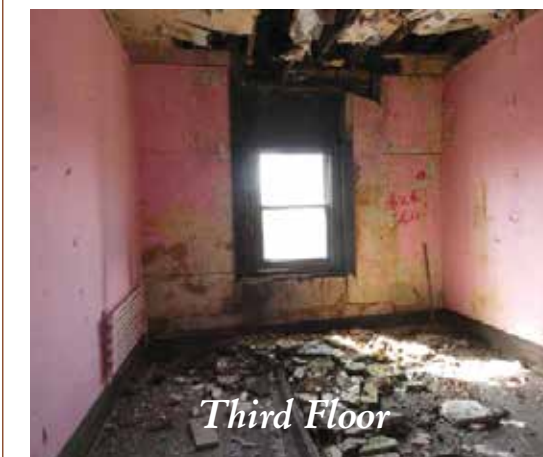
On the North side of the east half of the main corridor there were two rooms noted which had a total collapse of the 2nd Floor beams and walls. It appears that the floor beams deteriorated from moisture damage over time and failed.

above. The roof framing was also noted to be exposed in certain locations on the third floor and rot was noted in those areas with much of the ceiling systems collapsed or requiring removal. The number of areas affecting the wood beams and ceilings are limited but do extend to the rear of the floor and into the rooms in those areas.

Extensive removal of damaged ceilings and flooring and a general clean up is needed to further evaluate which structural members require replacement. This would be normal procedure for any such renovation.

The initial phase to be executed, once the building roof leaks have been repaired, would be to stabilize the flooring systems, i.e., beams and subflooring, where there is damage due to the rot noted herein. Each floor requires a thorough mapping and inspection of the floors to locate those areas which have been damaged. Once the mapping is completed a plan for installing shoring and subsequent repairs can be made so that the structural systems are "generally" secure without the risk of a failure.
