Comparative Analysis Executive summary

Saint Paul's Complex Garden City, NY, 11530

EXECUTIVE SUMMARY

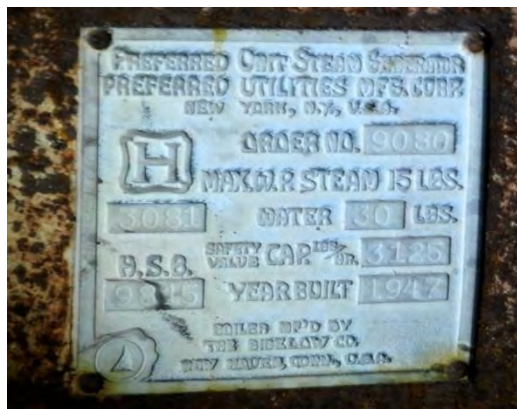
Existing boiler manufacturer by Preferred utilities

The building currently utilizes two boilers manufactured by Preferred Utilities as heating source. There are no ventilation or cooling systems in the building. All of the systems are old and should be replaced. As noted above, the system also lacks modern code-required ventilation. The control of the system is not automatic and no energy savings strategies are provided.

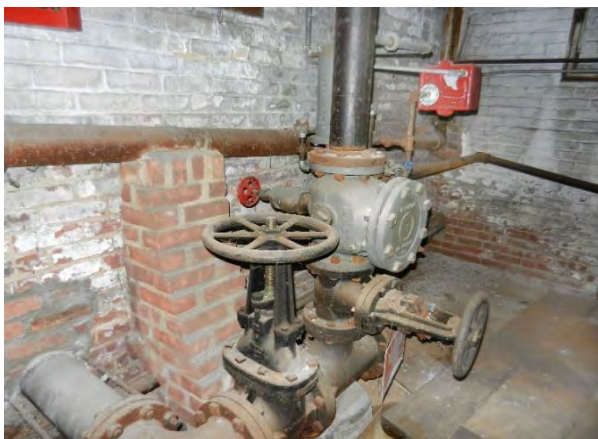
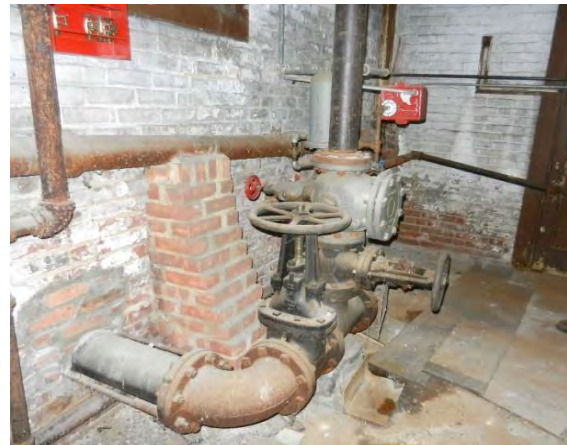
- A. Any Smoke Detectors installed throughout the building are inoperative, do not meet current codes and cannot be reused.
- B. Fire hose reels are installed at locations near fire exits. These do not meet current codes and the piping is not suitable for reuse due to age and corrosion.
- C. The current building is not protected with a comprehensive sprinkler fire system throughout. Sprinklers are only in the basement and hallways.
- D. The current gas service that enters the building is 2" low pressure gas line. That service has been abandoned.

- E. The plumbing piping system including waste, vent, water piping is original to the building. Systems show signs of failure, waste, and vent piping (cast iron) is cracking. There is some evidence of more updated piping in some areas where replacement was done due to failure. These systems cannot be reused.
- F. The plumbing fixtures in the building are original. Existing plumbing fixtures in the bathrooms include floor mounted tank type water closets. Urinals are wall hung type with flush valve. These fixtures do not conform to current water conservation code requirements.

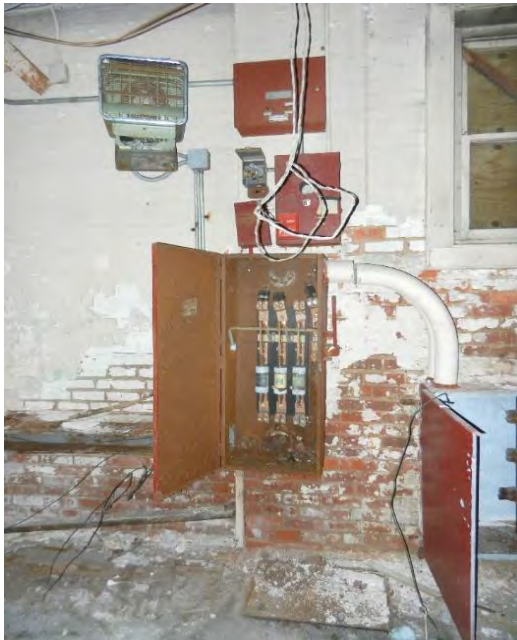
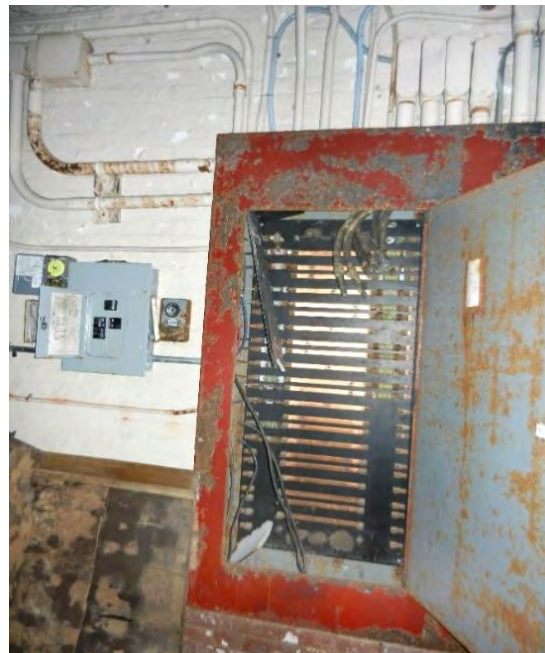
- A. The existing electrical service to the building is provided by underground feeders that run to service disconnects the electrical distribution is outdated. Most panel locations are not code compliant with regards to mounting heights.
- B. The entire electrical system is scavenged and needs to be replaced as it is non-compliant with current electrical loads and code. See photos above.

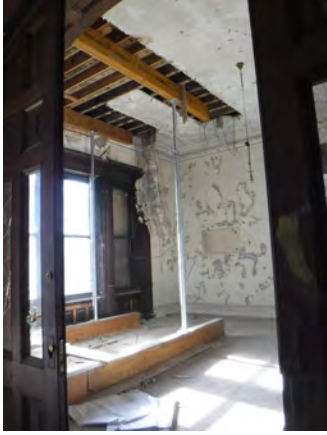
Shoring example on second floor

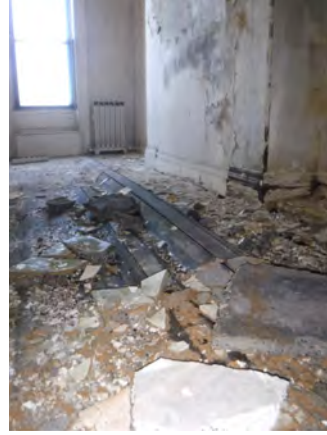
Floor damage

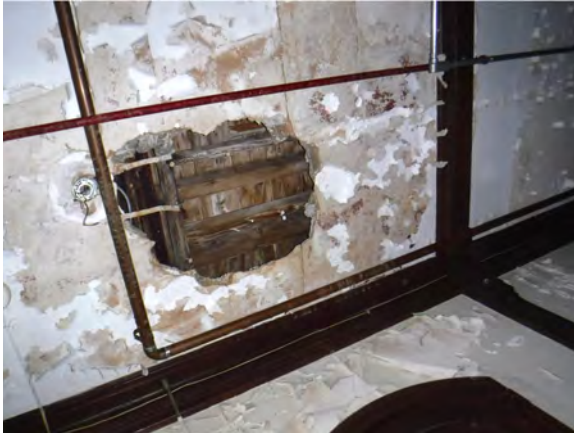
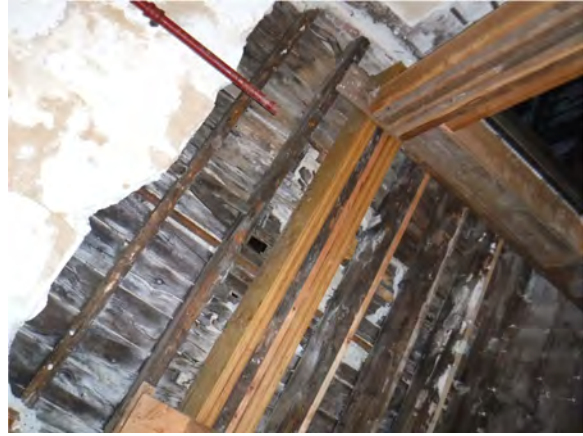
In some areas the ceiling, consisting of 1-1/2" thick fireproofing has delaminated from the ceiling. This is a safety concern as it leaves the wood joists exposed to fire but also due to the type of failure we are concerned of more ceiling delamination. The fire-proofing is attached to the wood joists with nails. In the areas where the plaster has fallen, we noticed the nails had rusted and broken away from the structure. It would be our assumption that more areas have this deterioration and further delamination is imminent.

Typical ceiling

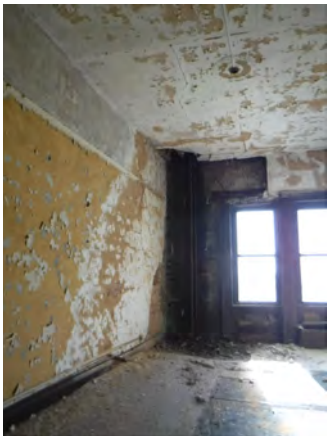
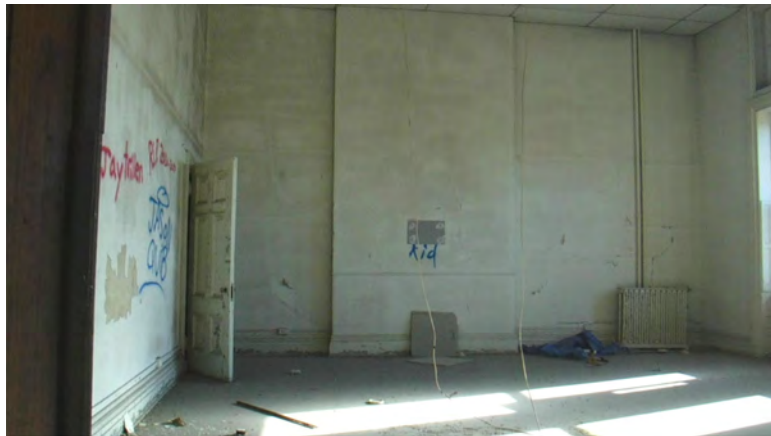
Typical room conditions

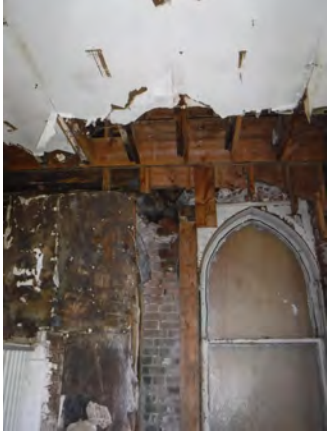
Interior damage towards roofs

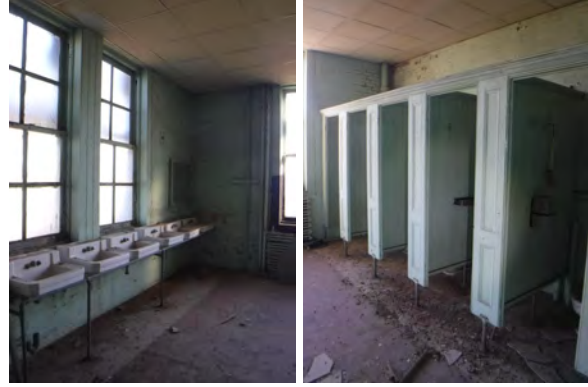
Typical restrooms
