Comparative Analysis Executive summary

Saint Paul's Complex Garden City, NY, 11530

EXECUTIVE SUMMARY

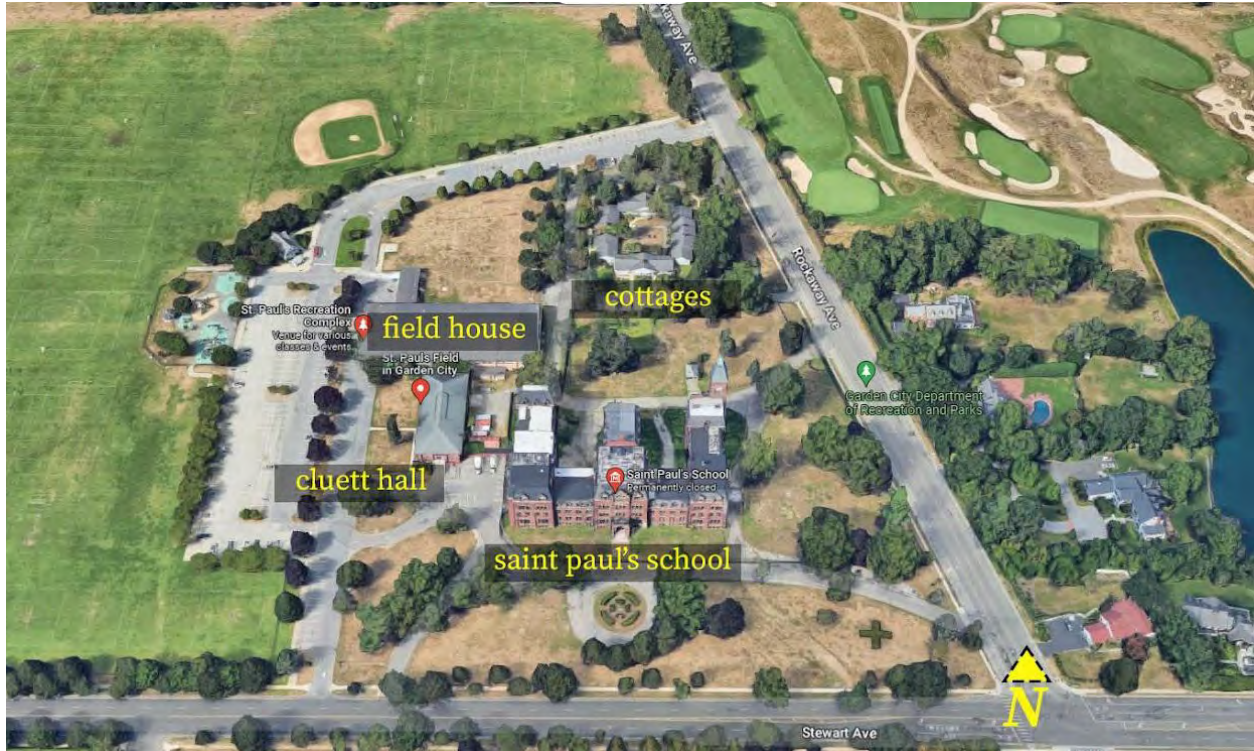
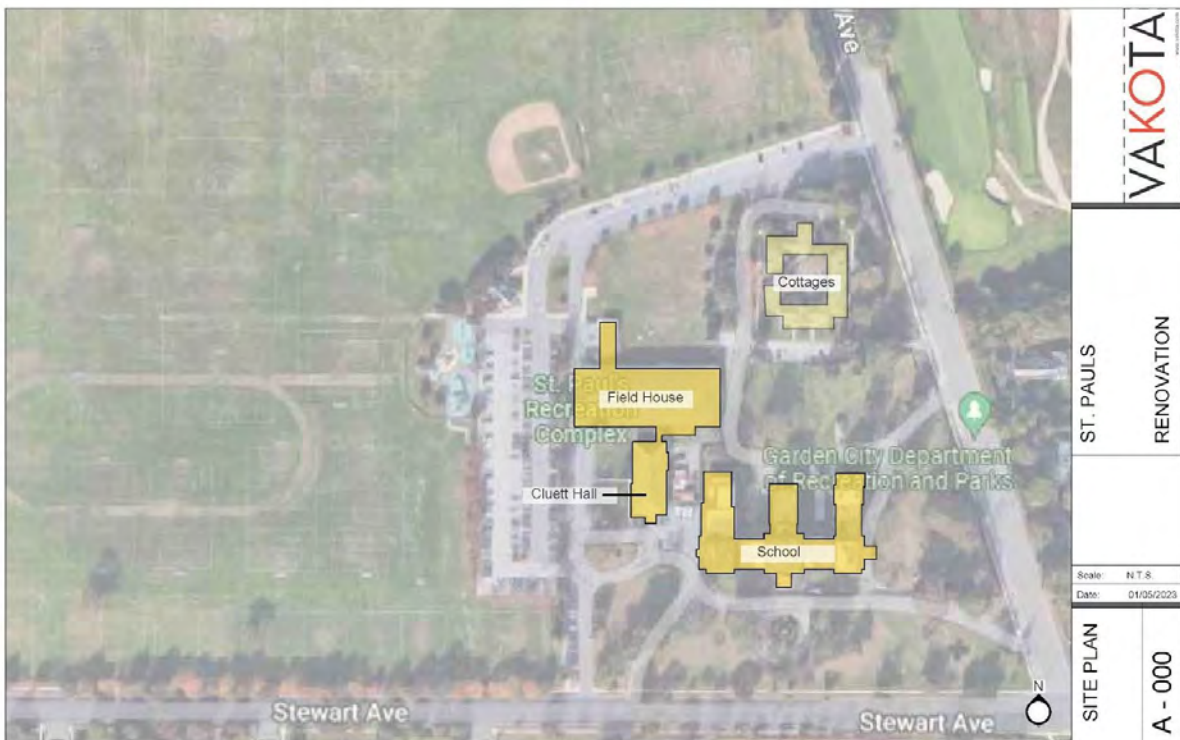
Existing Site

The following diagrams show the existing conditions as observed on December 09, 2022. No extensive probes or reviews were performed. Areas with noticeable deterioration, environmental hazards, and structural compromise have been highlighted. An extensive structural review was not performed although random samples of walls, ceilings, and floors were taken for asbestos and moisture testing.

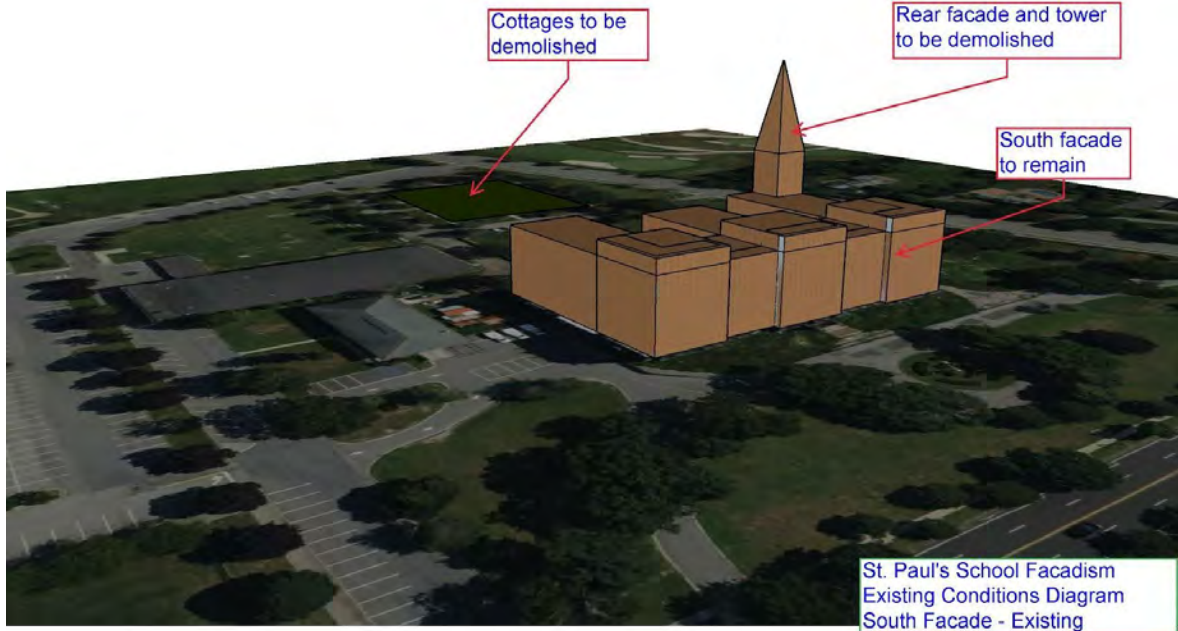
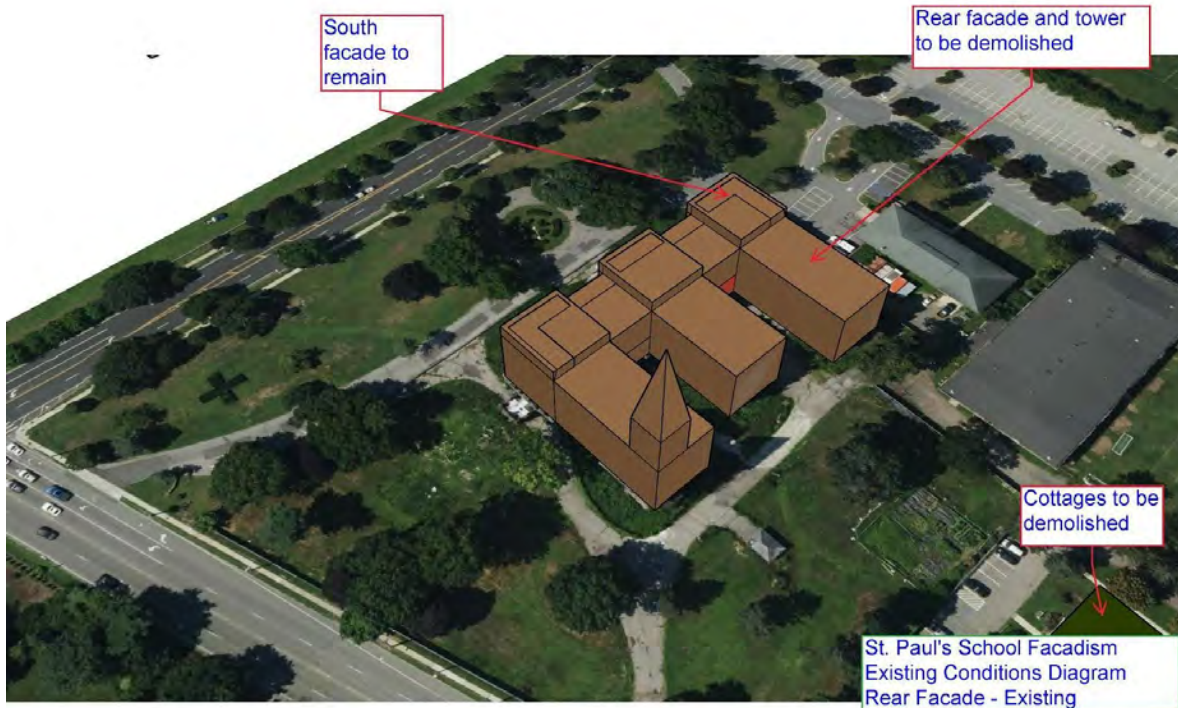
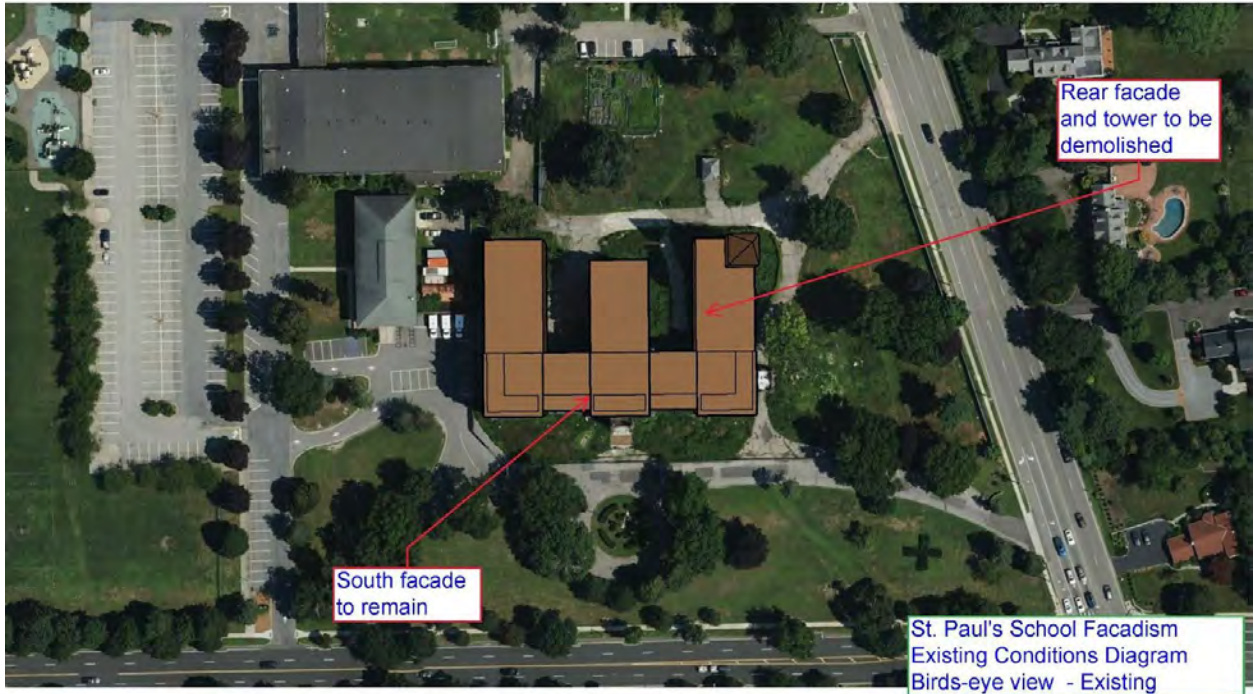
FACADISM DIAGRAMS VERSUS EXISTING CONDITIONS

South facade
to remain

Rear facade
and tower to be
demolished
